Reference	J/RYG_RG2/8046	Job/WIP No	33546
Customer Order No:	Unknown	Registration Number	AGILENTRAILER
Asset Number	HPTRAILER	Make/Model	Cartwright Cartwright
Chassis Number	94570	Engine Number	0000000000000
Start Date	2nd February 2014	Fleet Number	Not specified
Odometer	99 kms

**Safety Inspection, Independent TRAILER Safety Inspection for 'AGILENTRAILER'**  
(ref. 33546)

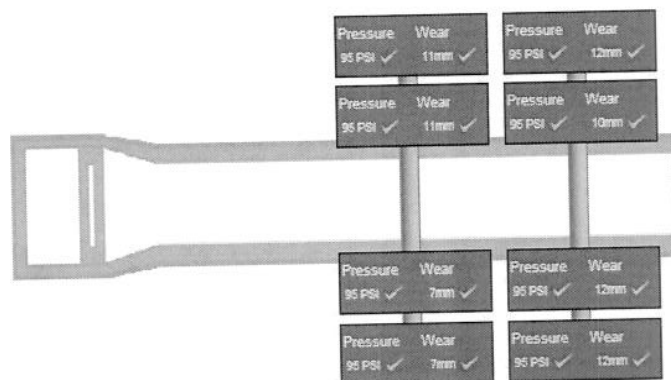
**Trailer Tyre Check**

**Trailer axle 1 offside outer**  
 Pressure: 95 PSI  
 Wear: 11mm  
 TMS Condition: OK  
 Brake Linings (% worn as per WS System) or: Non Applicable  
 Brake Linings Visual Check (% worn or mm left): 5 mm remaining on pad

**Trailer axle 1 offside inner**  
 Pressure: 95 PSI  
 Wear: 11mm  
 TMS Condition: OK  
 Brake Linings (% worn as per WS System) or: Non Applicable  
 Brake Linings Visual Check (% worn or mm left): Non Applicable

**Trailer axle 1 nearside inner**  
 Pressure: 95 PSI  
 Wear: 7mm  
 TMS Condition: OK  
 Brake Linings (% worn as per WS System) or: Non Applicable  
 Brake Linings Visual Check (% worn or mm left): Non Applicable

**Trailer axle 1 nearside outer**  
 Pressure: 95 PSI  
 Wear: 7mm  
 TMS Condition: OK  
 Brake Linings (% worn as per WS System) or:
